# PRODUCT ALERT

Clinical Center Standardization Committee

## Alaris® Medley™ Infusion Pumps September 2003 (1)

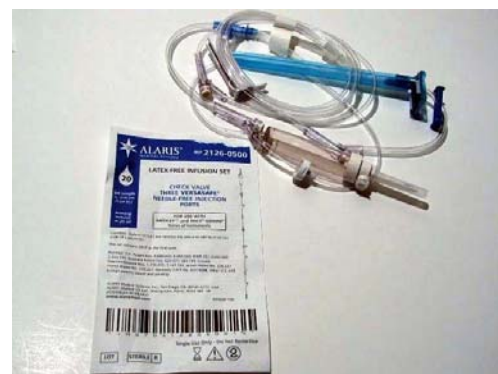
The 'back check' valve found on the Alaris primary administration sets may be defective.

1. Check for infusion rate on secondary line. If the rate is faster than the pump setting: Switch out the primary tubing; File an ORS; Return product and any available packaging information to MMD Nurse Consult Service, Room B1N238.
2. Be aware of the volume in the primary infusion line when you begin a secondary infusion. If the primary infusion volume is increasing, and you have determined the infusion height is not an issue, the 'back check' valve may be defective. Switch out the primary tubing as described above.
3. MMD is working to identify and switch out potentially defective product.

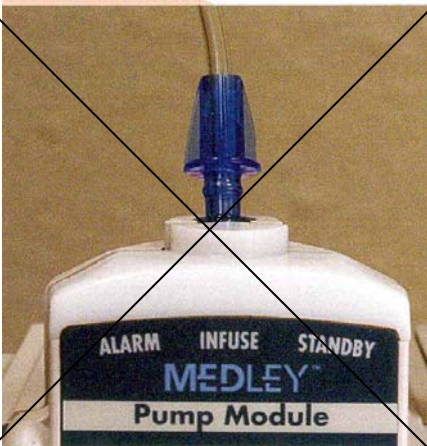
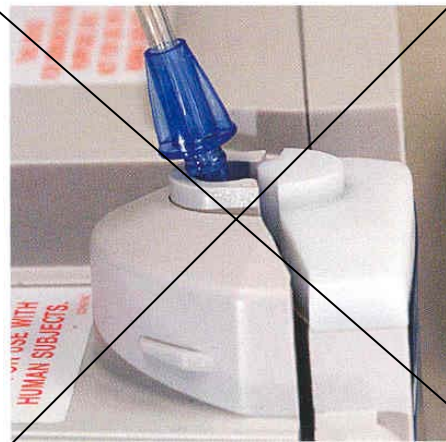
The blue upper fitment is tilted from the vertical; likely caused by applying lateral force to the upper fitment while closing and latching the door.

**THE SOLUTION: CLOSE THE ROLLER CLAMP AND RELOAD THE SET.**

**BE SURE TO PLACE THE UPPER FITMENT INTO THE RECEPTACLE FIRST.**

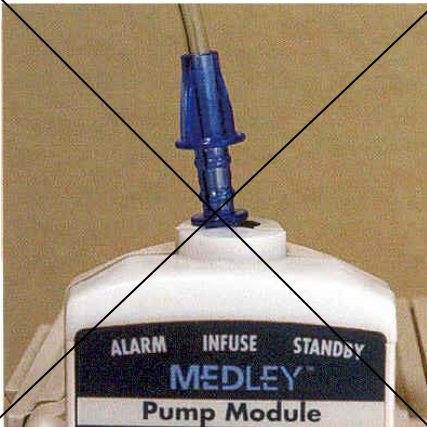
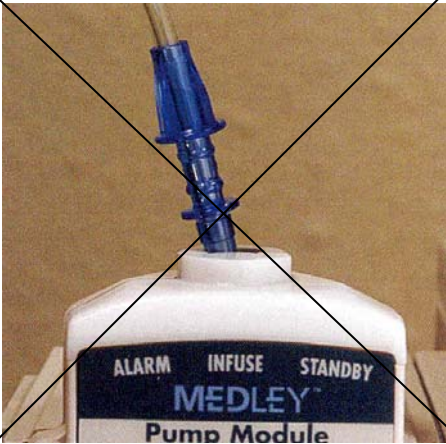
The blue upper fitment is elevated above the receptacle on the pump; likely caused by maintaining traction on the set while closing/ latching the door.
